**EXTERIOR PRESERVATION 2011-2012:**

### **Project Description**

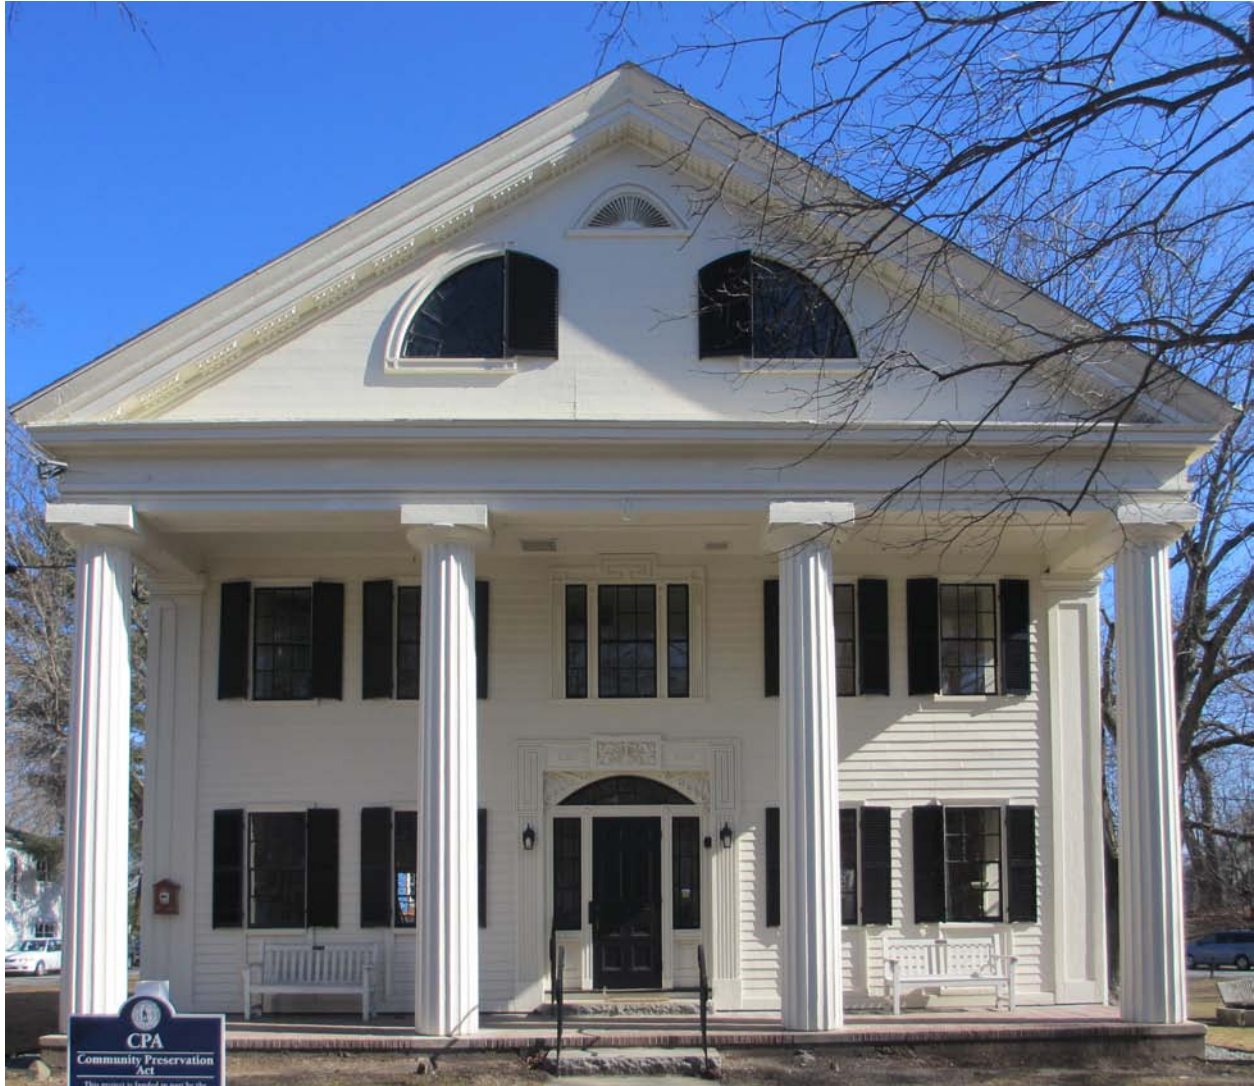
**Figure 1: Restored facade**

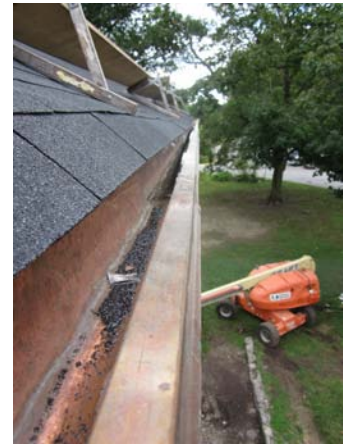
Work commenced in May with removal of the aluminum siding from all elevations. Work progressed well and in early June a discussion was held on site to review the condition of the copper skirt at the eaves of the roof. The skirt was in worse condition than had been hoped and the resoldering of seams was deemed impractical due to the worn material. Cleaning the existing solder and wire brushing the surface would wear through the copper. With the goal of limiting the added cost to the project it was elected to remove the drip line work from the project and complete that work with Town resources and to incur a minor increase in cost to remove the copper skirt, provide a new copper liner for the gutter and provide expansion joints for the gutters. This change added \$4,950 to the total project cost. At this time three tab asphalt shingles were requested to be substituted for the specified architectural style asphalt shingles since they were considered more sympathetic to the historic appearance of the Stone Building.

**Figure 2: Copper gutter liner**

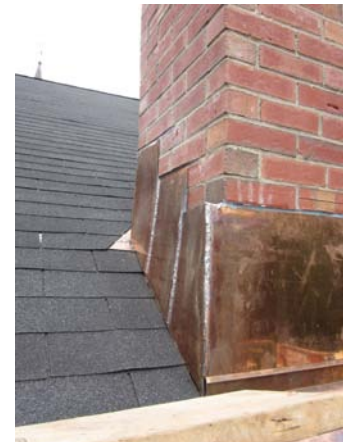
**Figure 3: Shoulder at chimney**

Repointing of the chimneys revealed an odd detail at the south east chimney shoulder where a copper cap had to be devised to cover what would have been upward facing mortar joints.

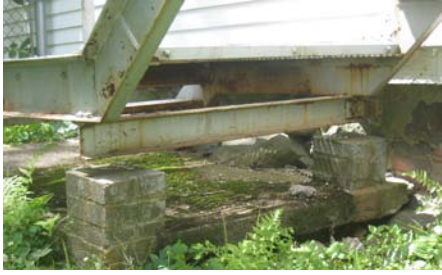
**Figure 4: Fire escape footing before removal**

The fire escape was removed, exposing a gap in the mortar at the foundation of the Stone Building. Though not large, because the site work had been removed from the contract the architect and owner discussed means of closing up the opening to prevent animals and water from entering the building. The Town was able to procure services for repointing the gap and installing the gravel drip along with hard plastic edging to keep the stones in place.

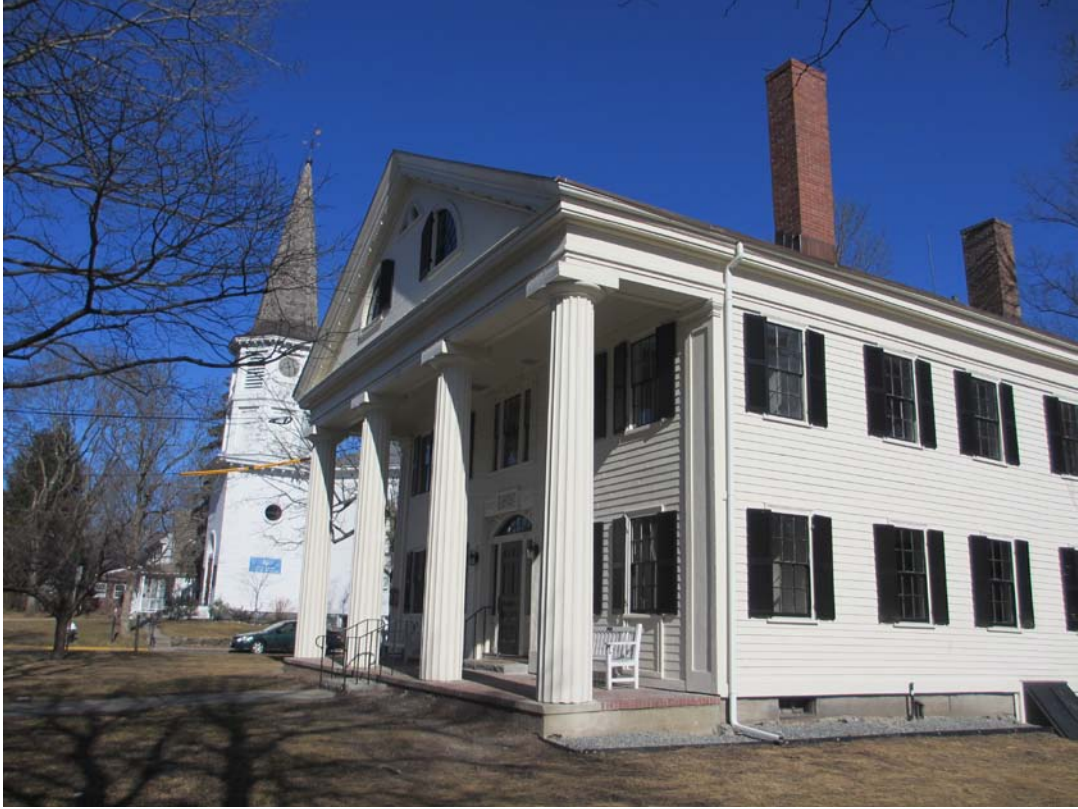
**Figure 5: Restored facade and partial east elevation**

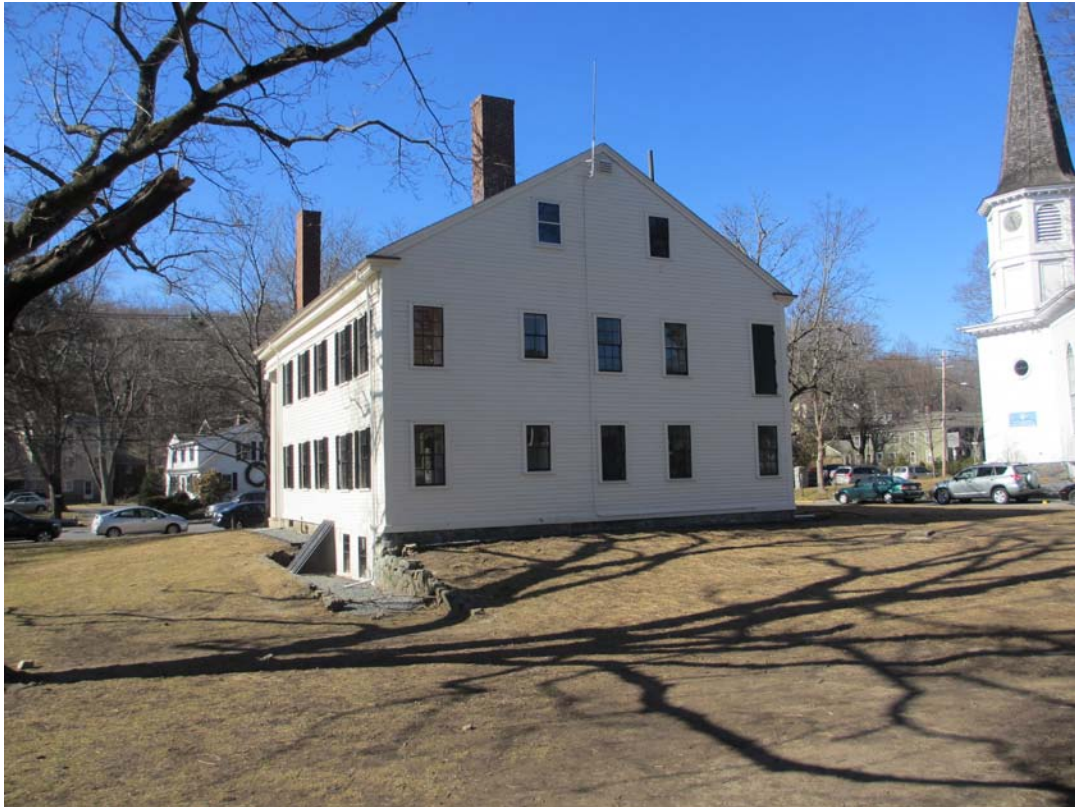
**Figure 6: Restored rear elevation**

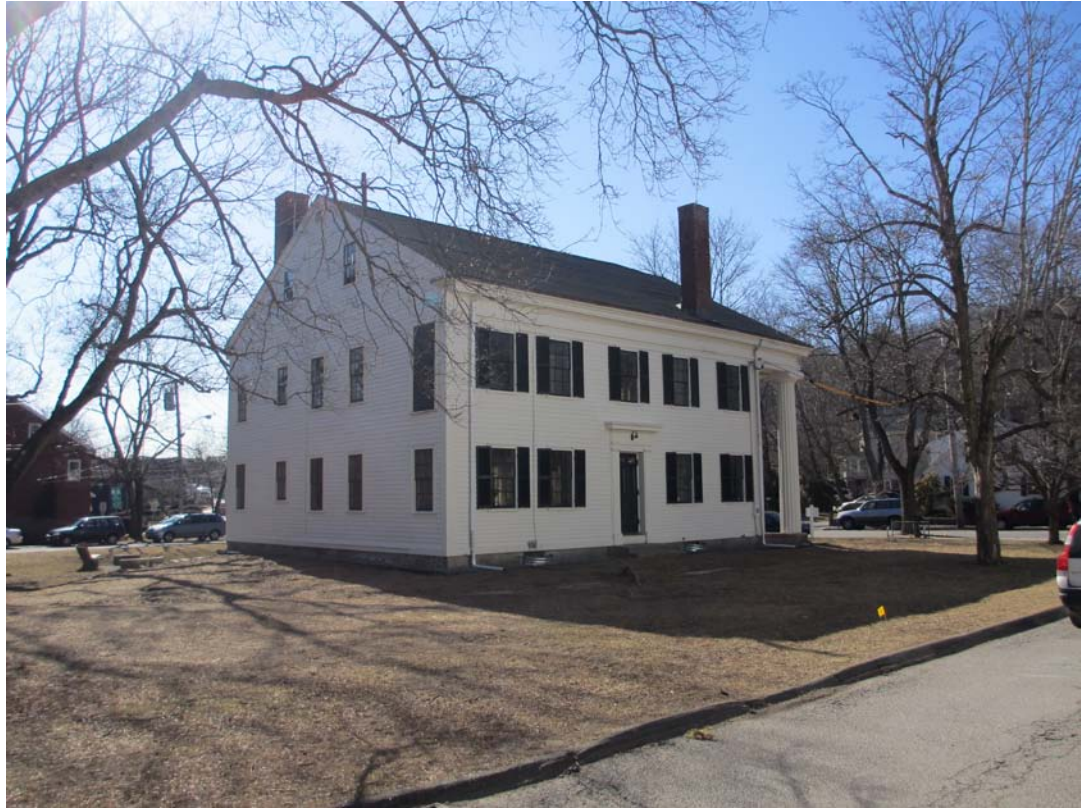
**Figure 7: Restored rear and west elevations**
