EXTERIOR PRESERVATION 2011-2012:

Project Description

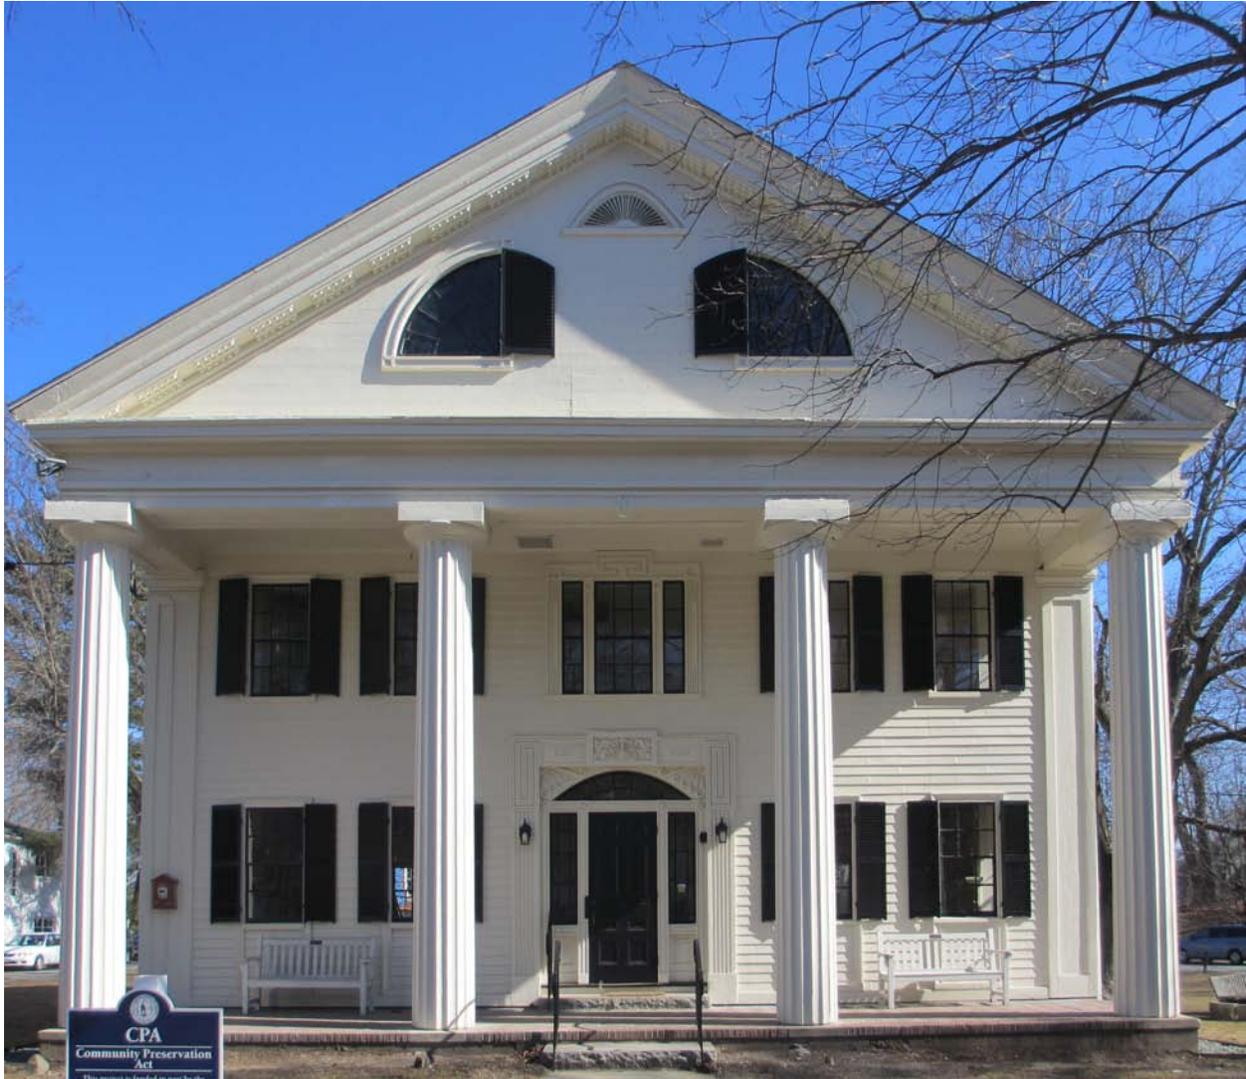
Figure 1: Restored facade

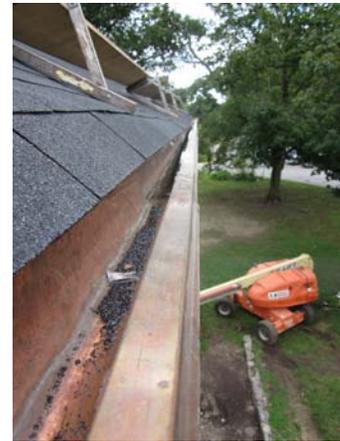
Work commenced in May with removal of the aluminum siding from all elevations. Work progressed well and in early June a discussion was held on site to review the condition of the copper skirt at the eaves of the roof. The skirt was in worse condition than had been hoped and the resoldering of seams was deemed impractical due to the worn material. Cleaning the existing solder and wire brushing the surface would wear through the copper. With the goal of limiting the added cost to the project it was elected to remove the drip line work from the project and complete that work with Town resources and to incur a minor increase in cost to remove the copper skirt, provide a new copper liner for the gutter and provide expansion joints for the gutters. This change added \$4,950 to the total project cost. At this time three tab asphalt shingles were requested to be substituted for the specified architectural style asphalt shingles since they were considered more sympathetic to the historic appearance of the Stone Building.

Figure 2: Copper gutter liner

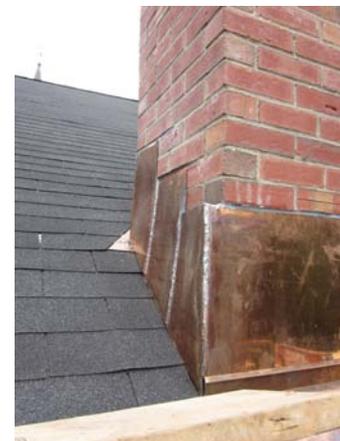
Figure 3: Shoulder at chimney

Repointing of the chimneys revealed an odd detail at the south east chimney shoulder where a copper cap had to be devised to cover what would have been upward facing mortar joints.

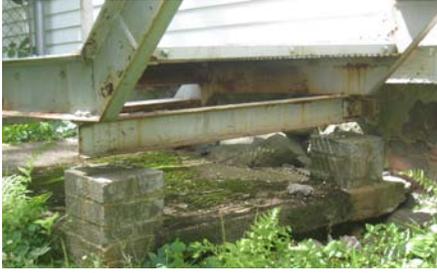
Figure 4: Fire escape footing before removal

The fire escape was removed, exposing a gap in the mortar at the foundation of the Stone Building. Though not large, because the site work had been removed from the contract the architect and owner discussed means of closing up the opening to prevent animals and water from entering the building. The Town was able to procure services for repointing the gap and installing the gravel drip along with hard plastic edging to keep the stones in place.

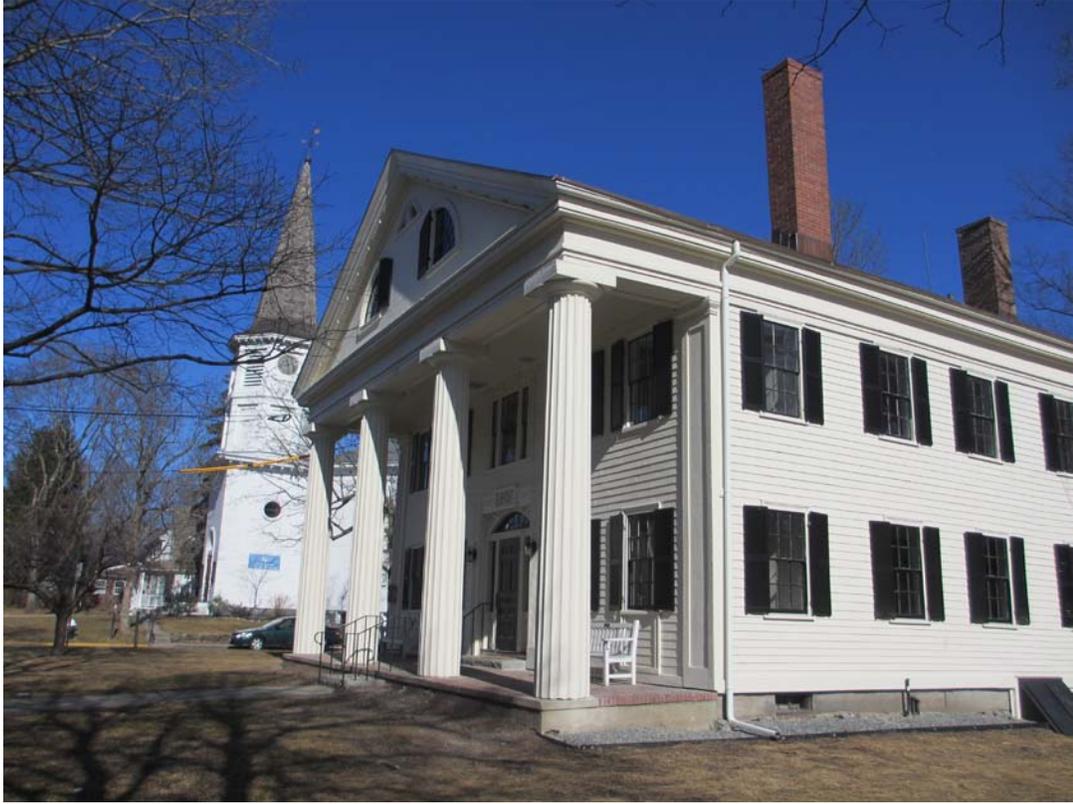
Figure 5: Restored facade and partial east elevation

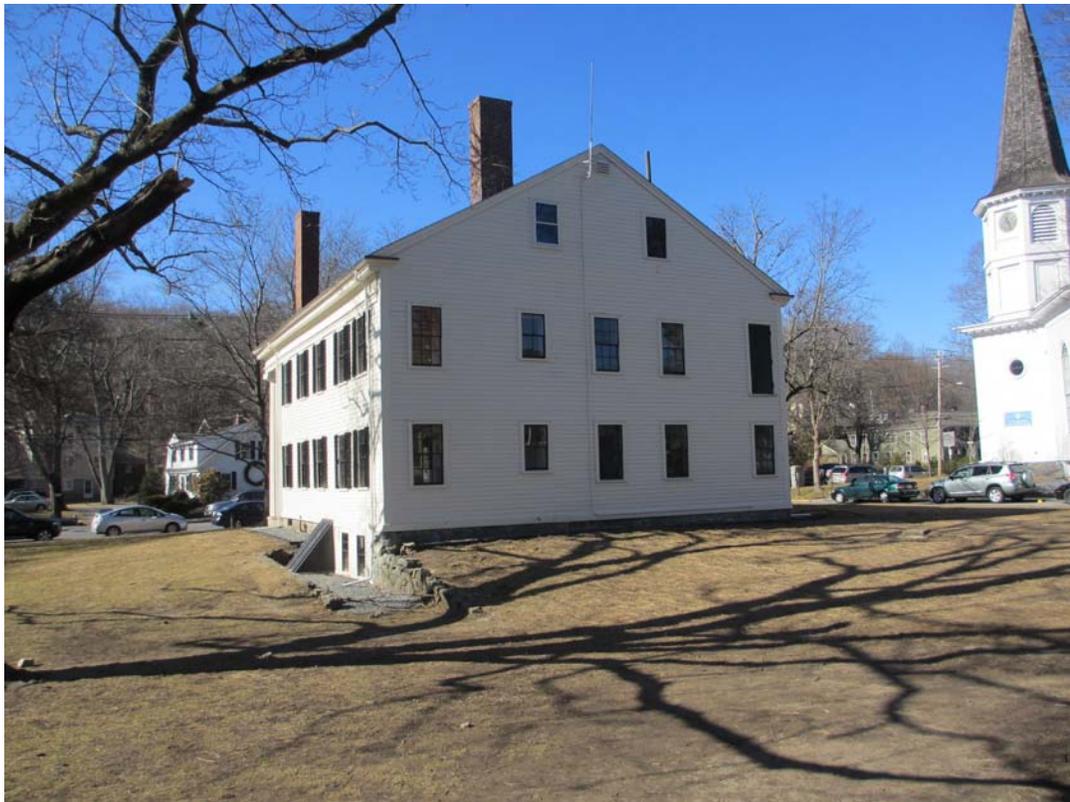
Figure 6: Restored rear elevation

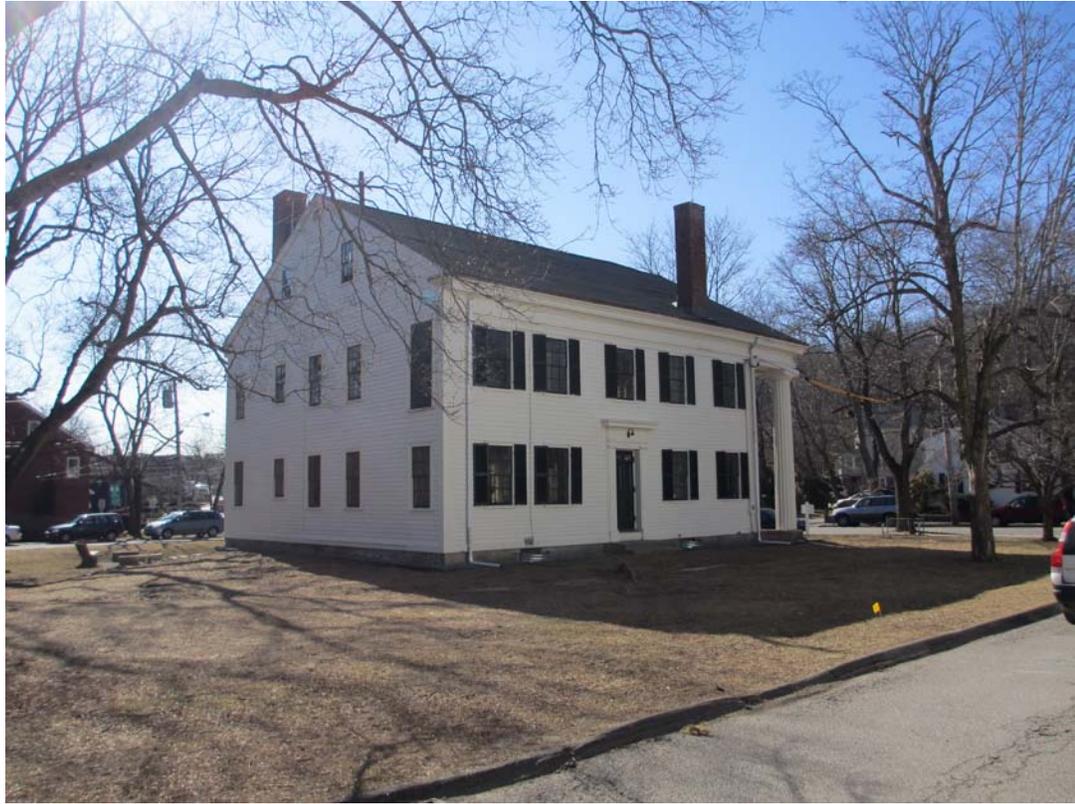
Figure 7: Restored rear and west elevations
