Town of Lexington Department of Public Facilities

Article 20 (d)

Public Service Building Vehicle Storage Floor Repair

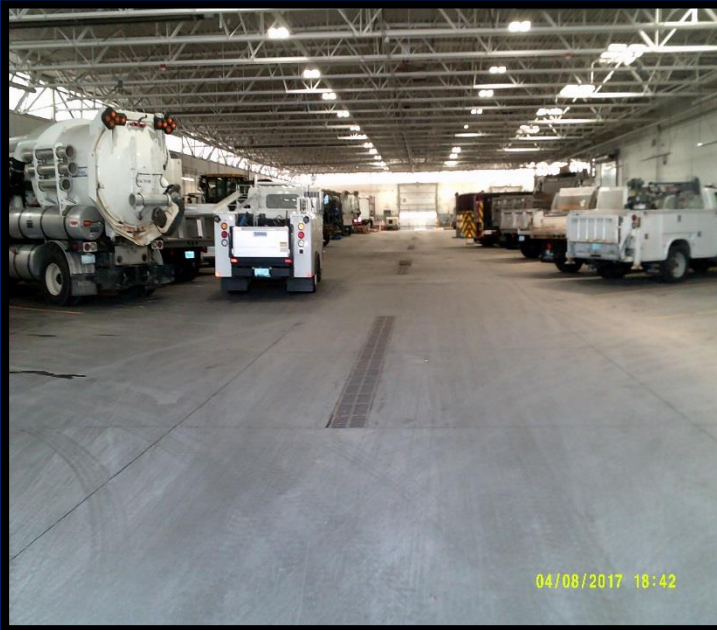
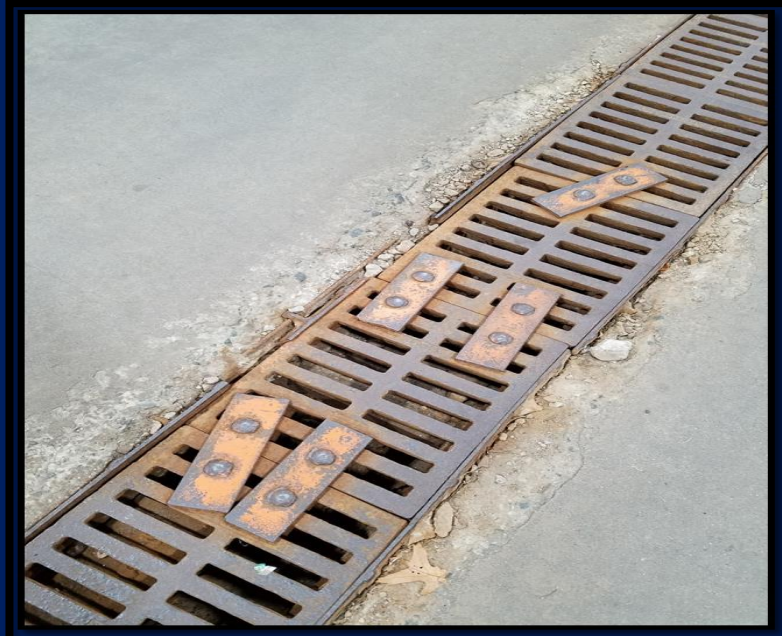
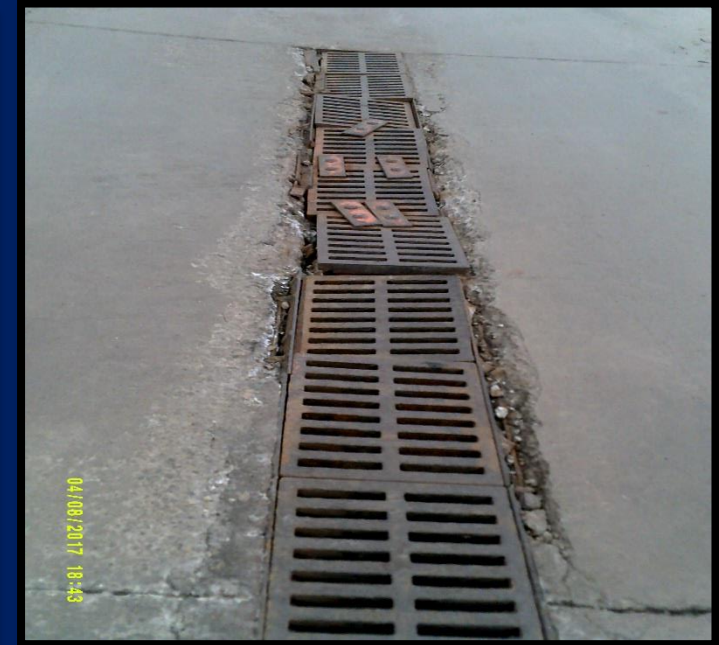
Conditions

- Simpson Gumpertz and Heger studied present concrete issues and original construction details
- SGH study points towards salt-laden standing water that has dramatically increased the rate of corrosion in floor drains/trench
- SGH recommends scope of work
- SGH estimate project cost for capital request

Spalled/delaminated concrete at floor drains/trench in Vehicle Staging Area

- Remove and Repair spalled and delaminated Concrete
- Remove and install Trench drains
- Grout and Seal with penetrating sealer
- Protective coatings on grates and metals
- Detailed preventative maintenance program
