MEMORANDUM

SUBJECT: Traffic Circulation, Access and Parking Study
Cotting School
Lexington, Massachusetts

Vanasse & Associates, Inc. (VAI) has conducted a Traffic Circulation, Access and Parking Study for the Cotting School located at 453 Concord Avenue in Lexington, Massachusetts. This assessment identifies existing parking and traffic conditions and reviews access requirements, circulation, and safety considerations. As part of this assessment field observation of existing conditions, parking demand and overall circulation was completed. Recommendations were made to improve safety conditions, circulation and parking at the school.

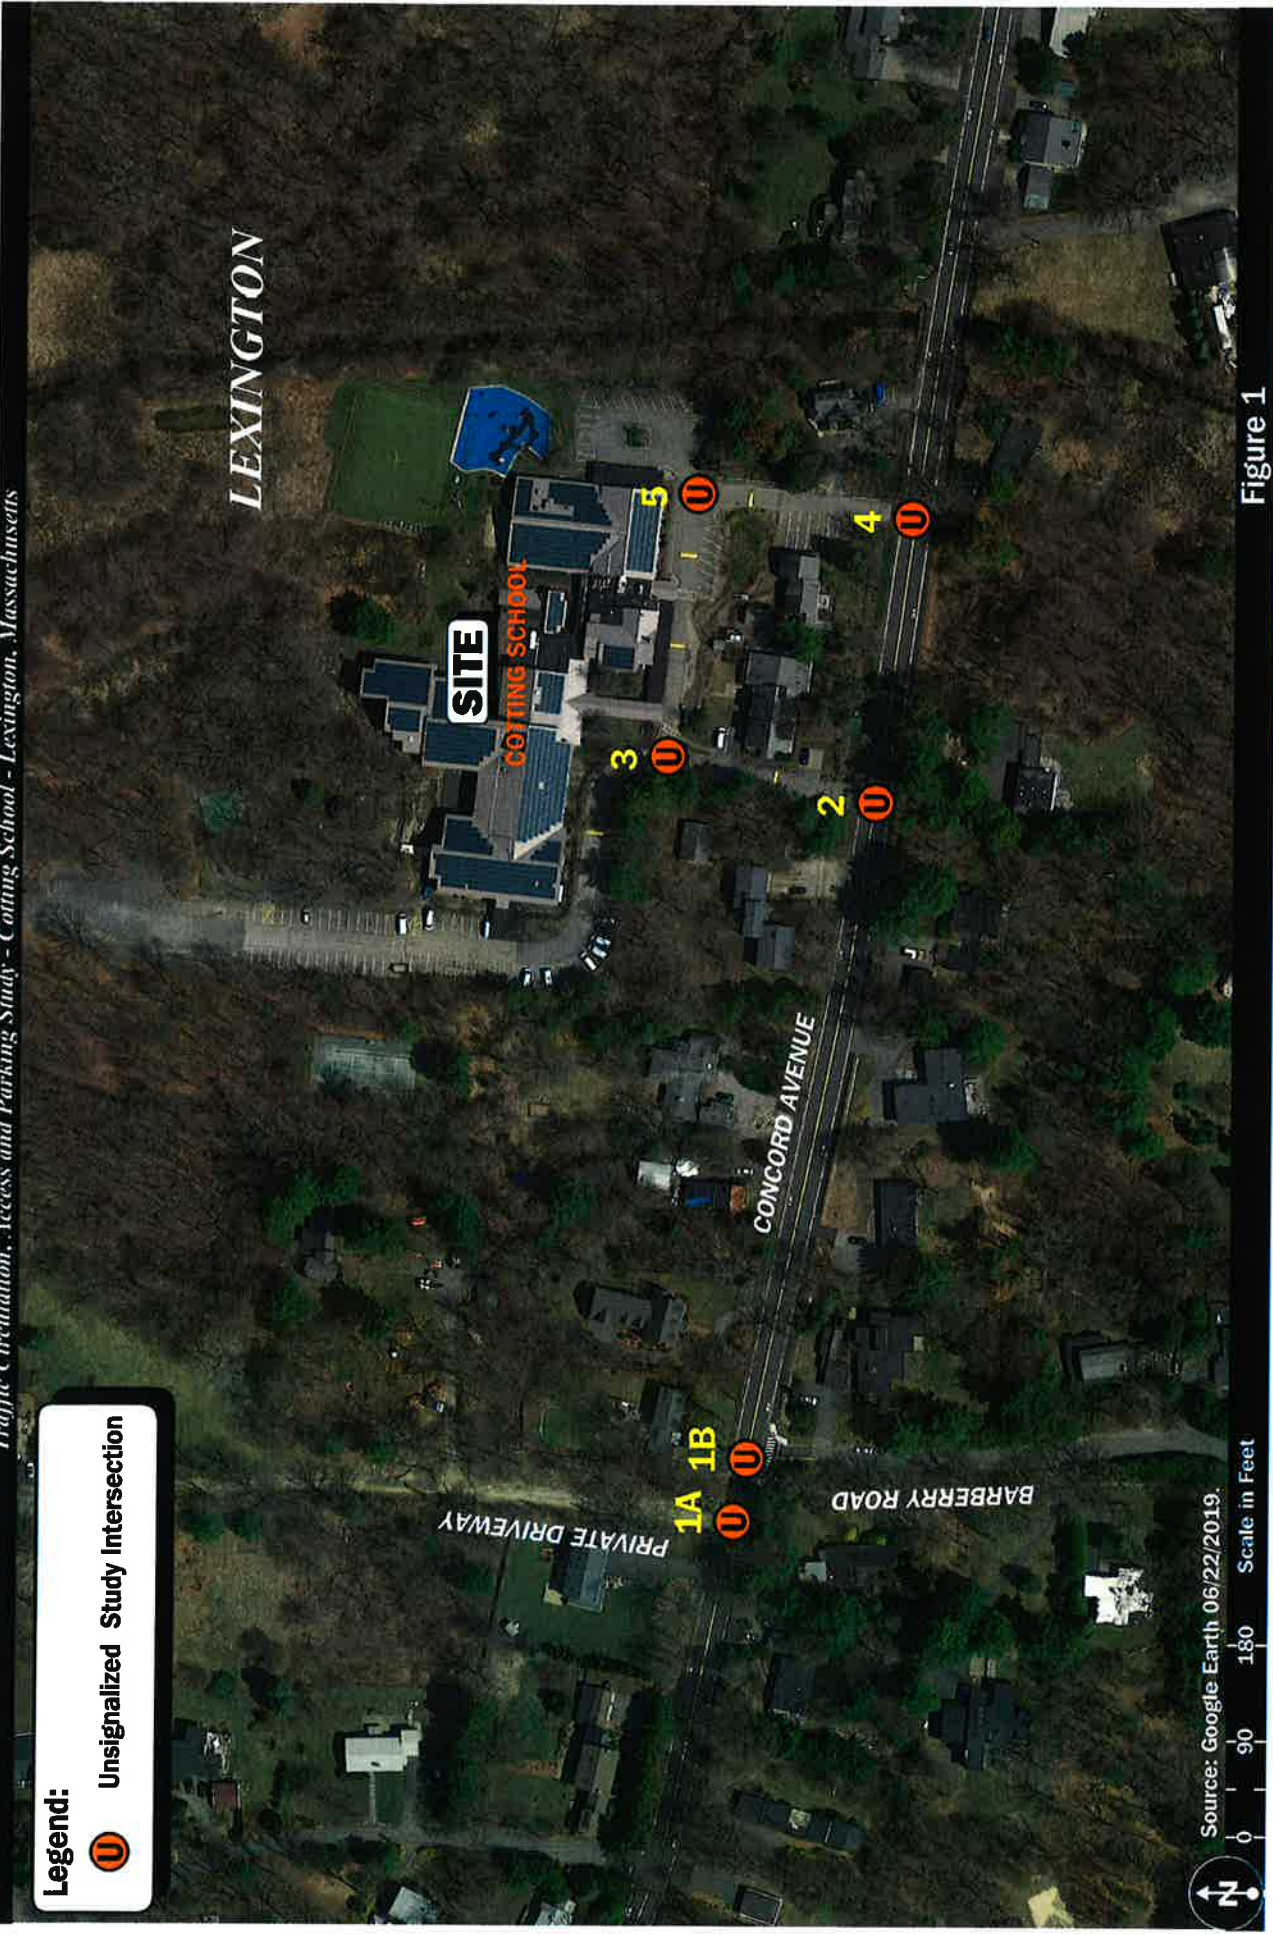
Figure 1
Site Location and Study Area Map

A comprehensive field inventory of existing conditions at the school was conducted in November 2019. The field investigation consisted of an inventory of existing roadway geometrics, traffic volumes, operating characteristics, parking inventory, as well as safety data. Figure 1 depicts the project study area.

Legend:
⓪ Unsignalized Study Intersection

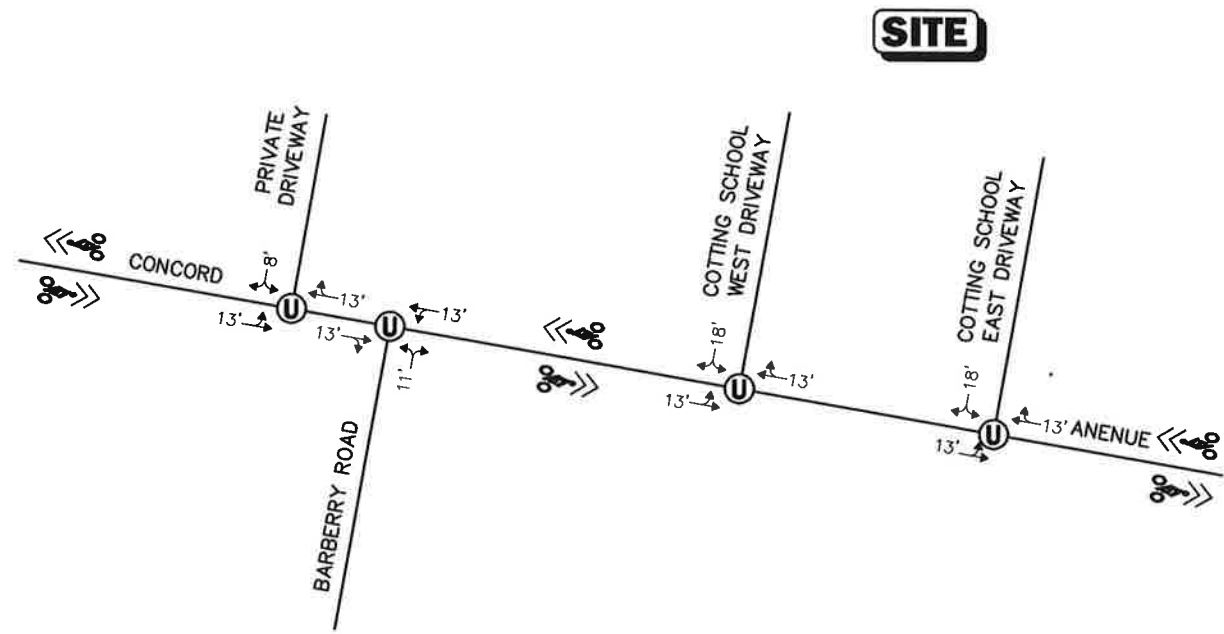
xx' \leftrightarrow Lane Use and Travel Lane Width

$\uparrow\uparrow$ "Sharrow" Marking

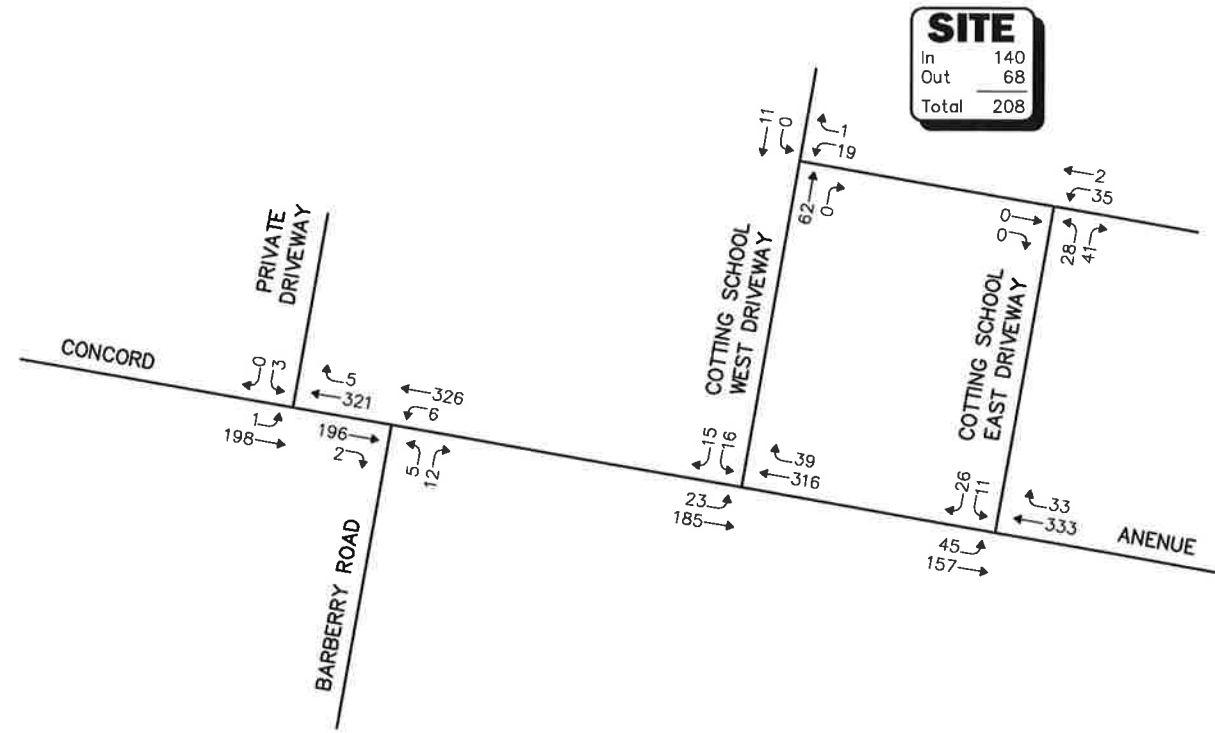
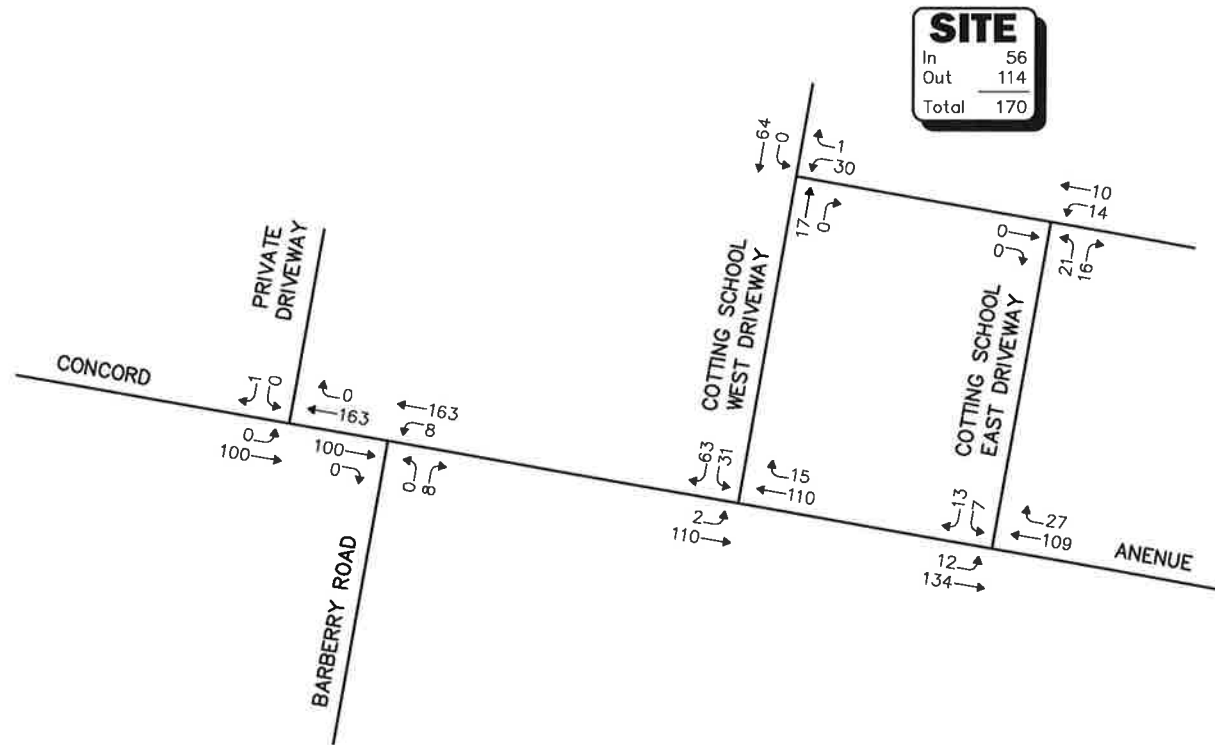
Not To Scale **Figure 3**

WEEKDAY MORNING PEAK HOUR (7:45 - 8:45 AM)

WEEKDAY EVENING PEAK HOUR (2:30 - 3:30 PM)

A summary of the peak-hour traffic counts is presented in Figure 3. As shown in Figure 3, the school generates a total of 208 vehicle trips (140 in/68 out) during the morning peak hour and 170 trips (56 in/114 out) during the afternoon peak hour.

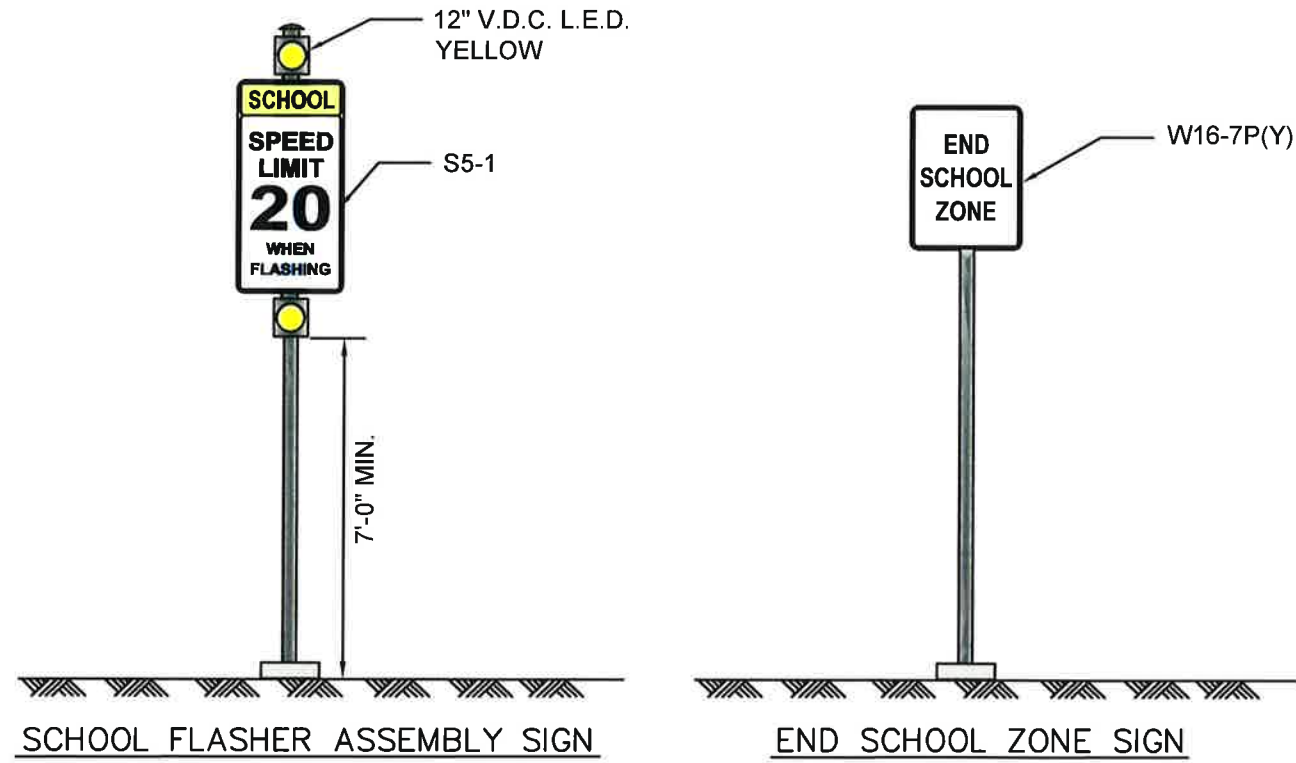
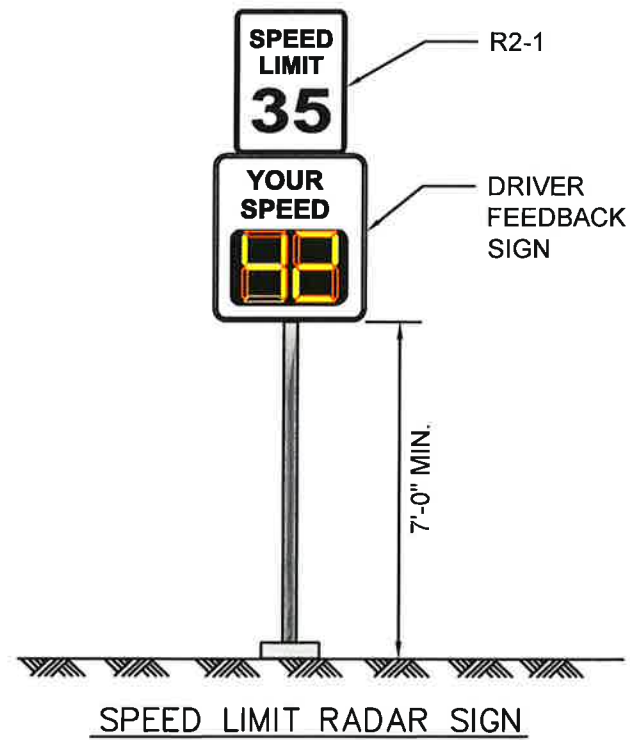
Note: Location of sign installation to be determined.

Based upon observations of traffic conditions and vehicle speeds, it is recommended that a school zone be established along Concord Avenue which is typical for any school. The Manual on Uniform Traffic Control Devices (MUTCD) establishes standard school zone signs to delineate the beginning and end of the school zone with a 20 mph speed limit during drop-off and pick-up times to alert road users and give proper notice of the school zone. The applicant shall coordinate with the Town to establish the school zone. The school zone signs are depicted in Figure 4.
